UNDERWATER BRIDGE INSPECTION REPORT

STRUCTURE NO. 88594
CSAH NO. 44
OVER THE
INDIAN CREEK
DISTRICT 1 – ST. LOUIS COUNTY

PREPARED FOR THE
MINNESOTA DEPARTMENT OF TRANSPORTATION
BY
COLLINS ENGINEERS, INC.
JOB NO. 3512 (CEI 6)

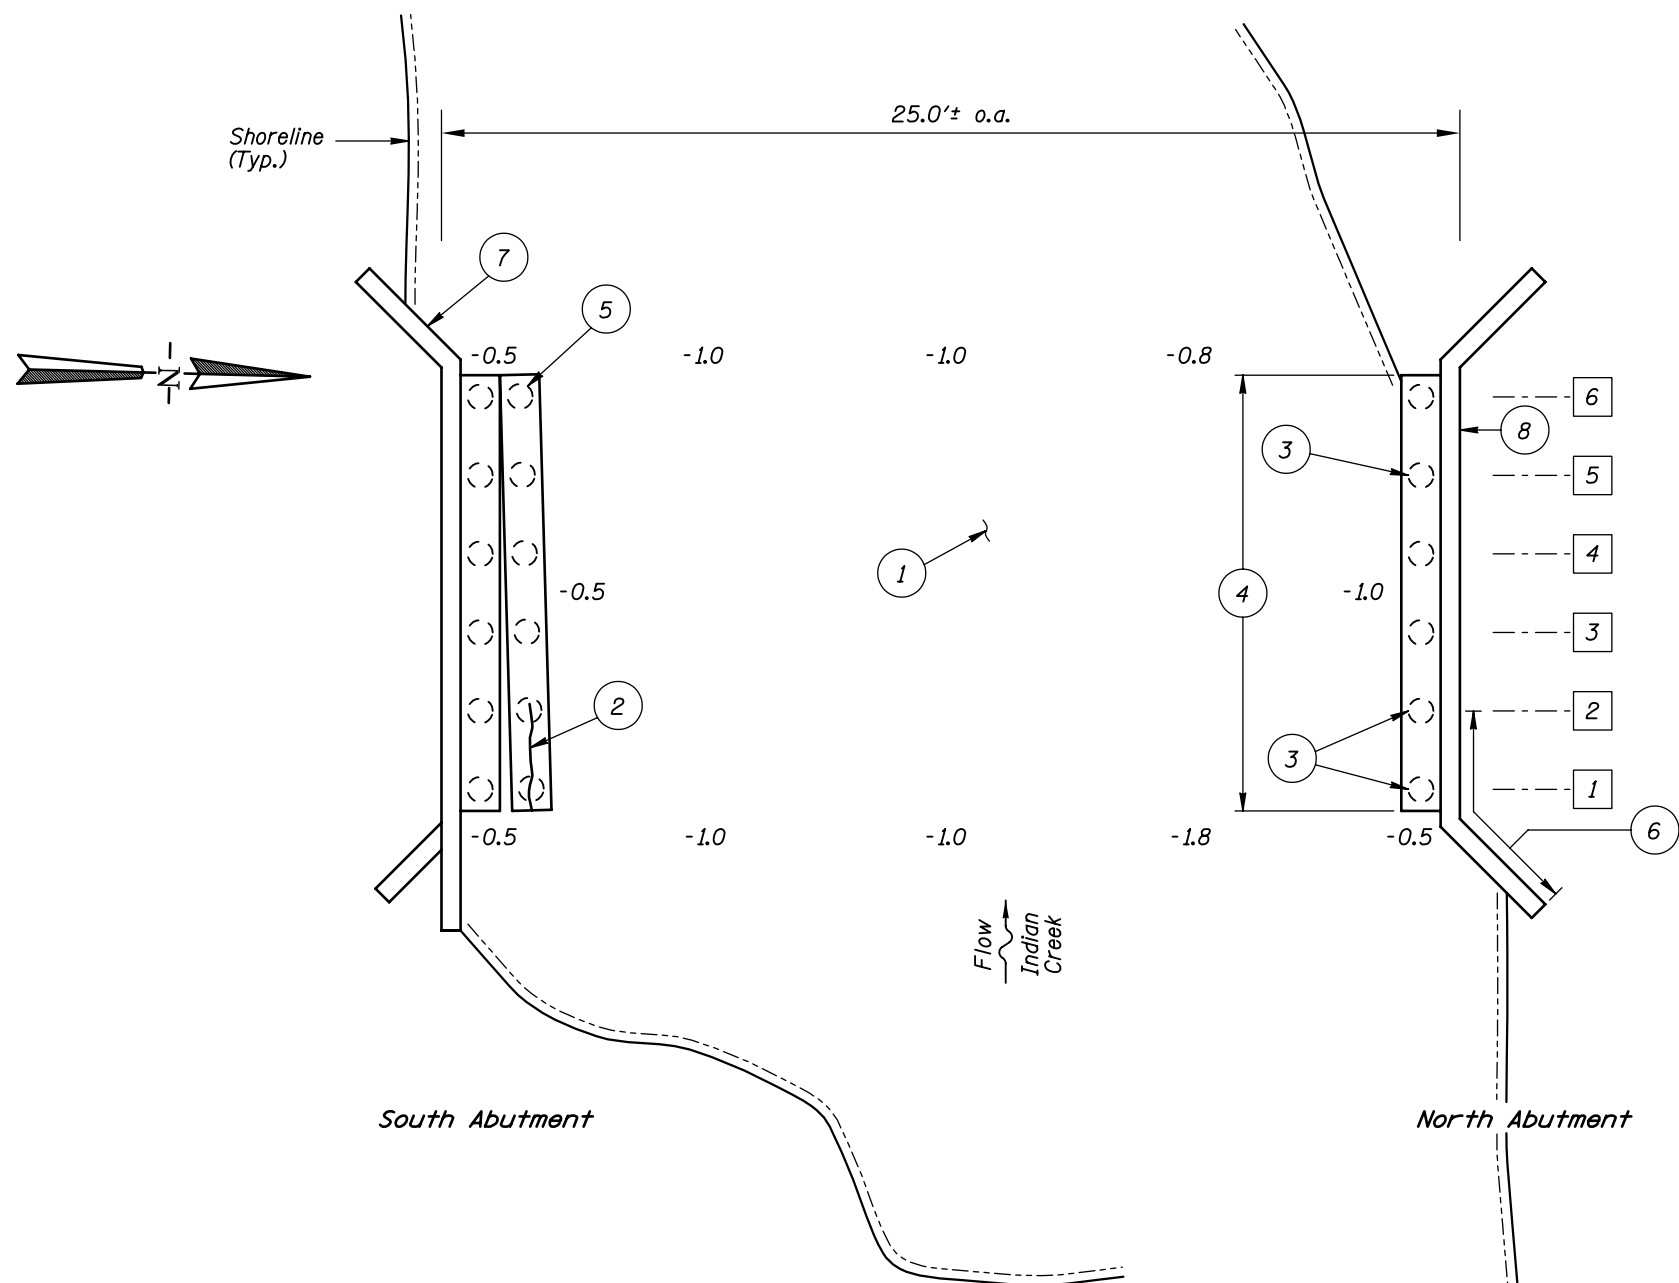
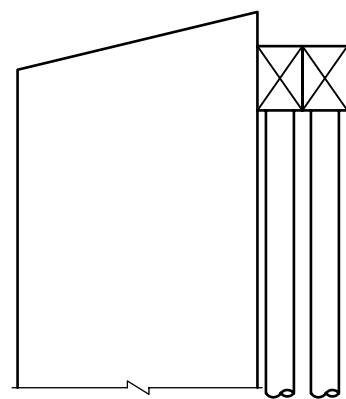
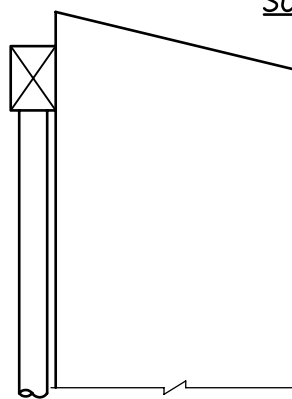
INSPECTION AND SOUNDING PLAN

- ① The channel bottom consisted of silty sand with a maximum probe rod penetration of 1.5 feet.
- ② The pile cap exhibited a 3-inch-wide vertical split which extended from the end of the pile cap to Pile 2.

- ③ The timber pile exhibited splitting and delamination around the entire circumference with the outer 1 inch shell being the most affected.
- ④ The pile cap was rotated towards the embankment and was held in place with steel beams and shims.

- ⑤ The timber pile exhibited a 1/2-inch-wide, 1.5-inch-deep split extending from the pile cap to the mudline.
- ⑥ The wingwall has failed and the east end of the backwall exhibited considerable movement with backfill escaping through 1-inch-gaps between the planking.

- ⑦ Bottom plank was 6 inches above mudline with 1 foot of penetration behind wall.
- ⑧ Portion of backwall exhibited 1-foot-wide by 6-inch-high gap with 6 inches of penetration and signs of backfill escaping.

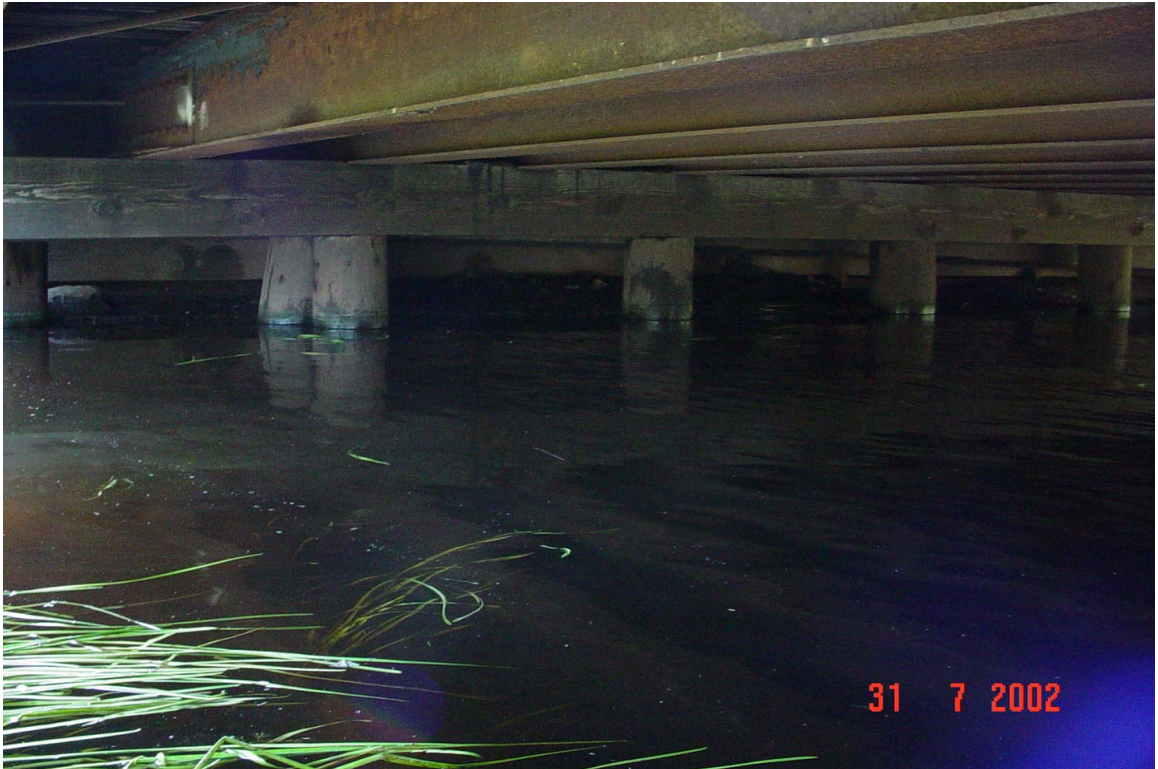
Photograph 1. View of the South Abutment, Looking Southwest.

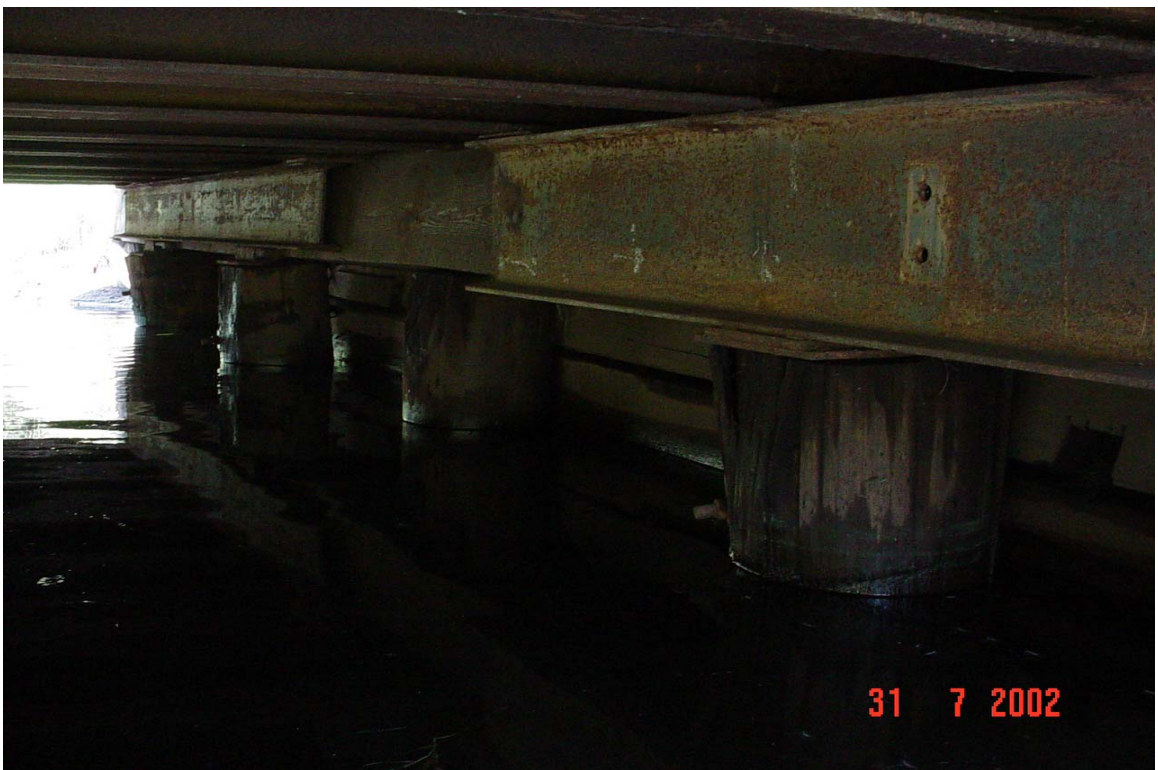
Photograph 2. View of the North Abutment, Looking Northwest.

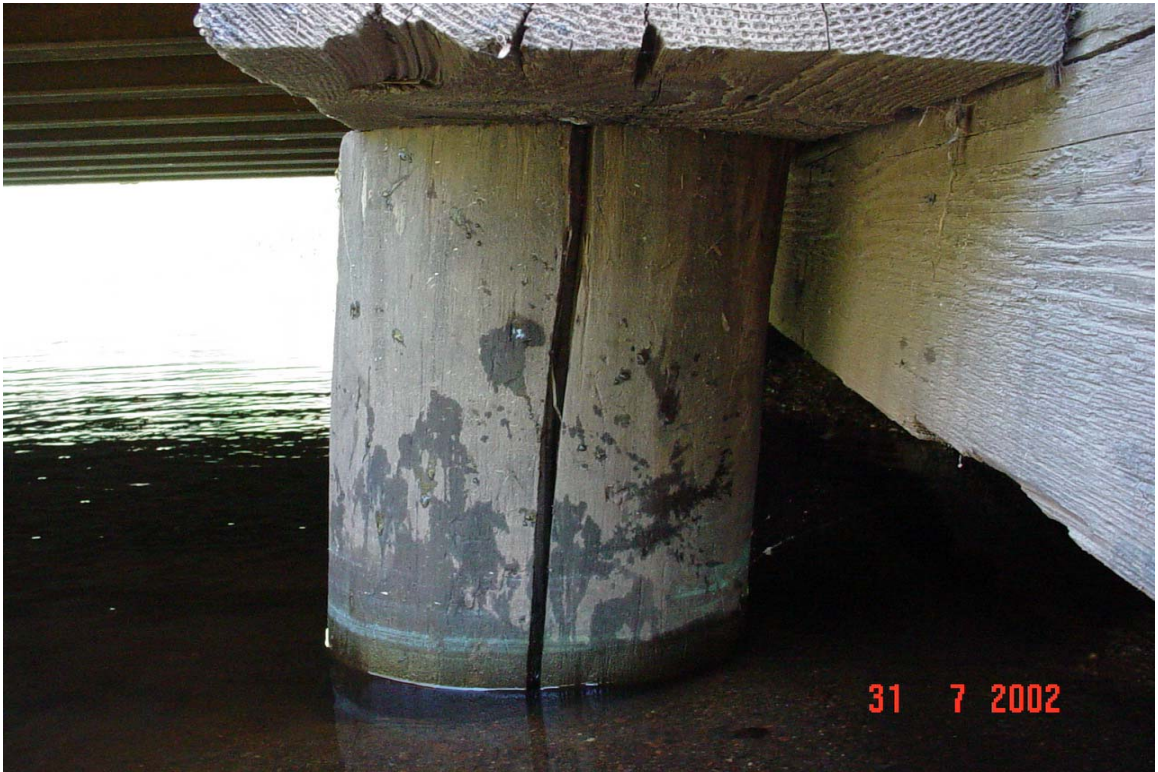
- (D) Pile 6 at the South Abutment exhibited a 1/2-inch-wide, 1.5-inch-deep split extending from the pile cap to the mudline.
- (E) The bottom plank of the Southwest Wingwall was 6 inches above mudline with 1 foot of penetration behind the wall.

Photograph 3. View of Pile 6 at South Abutment, Looking East.

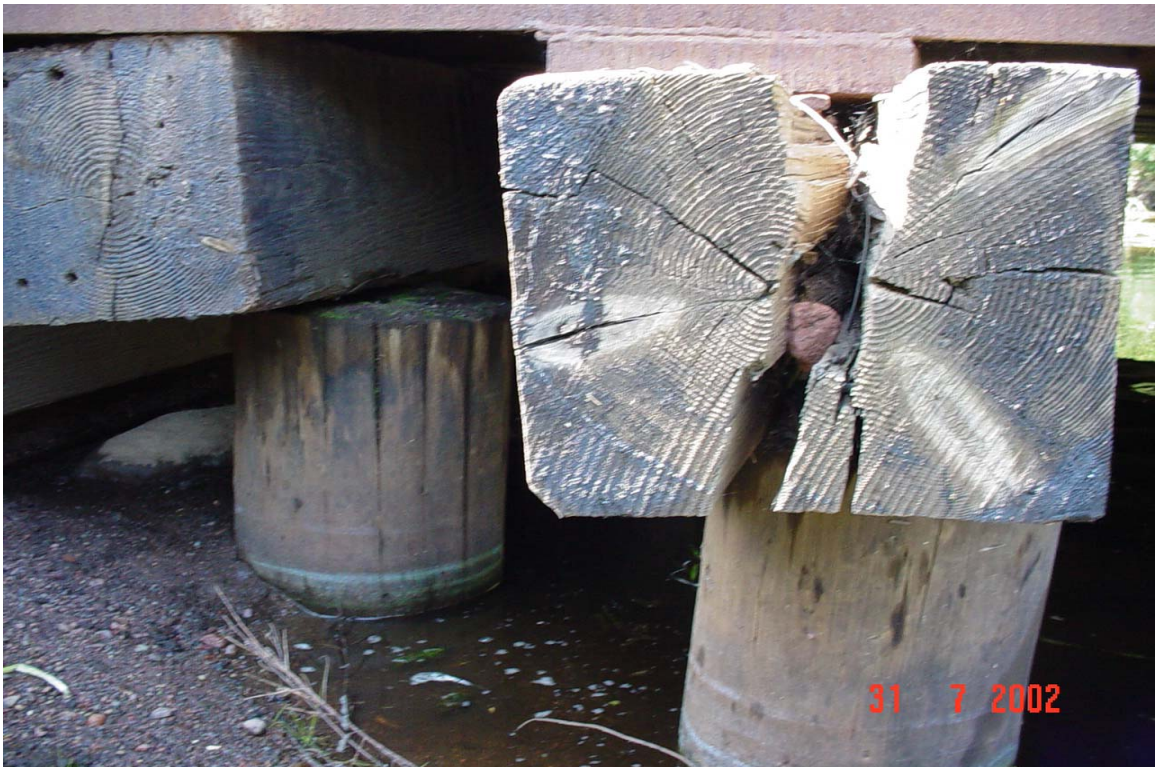
- (A) The east end of the pile cap at the South Abutment exhibited a 3-inch-wide vertical split, which extended from the end of the pile cap to Pile 2.

Photograph 4. View of South Abutment Pile Cap, Looking West.

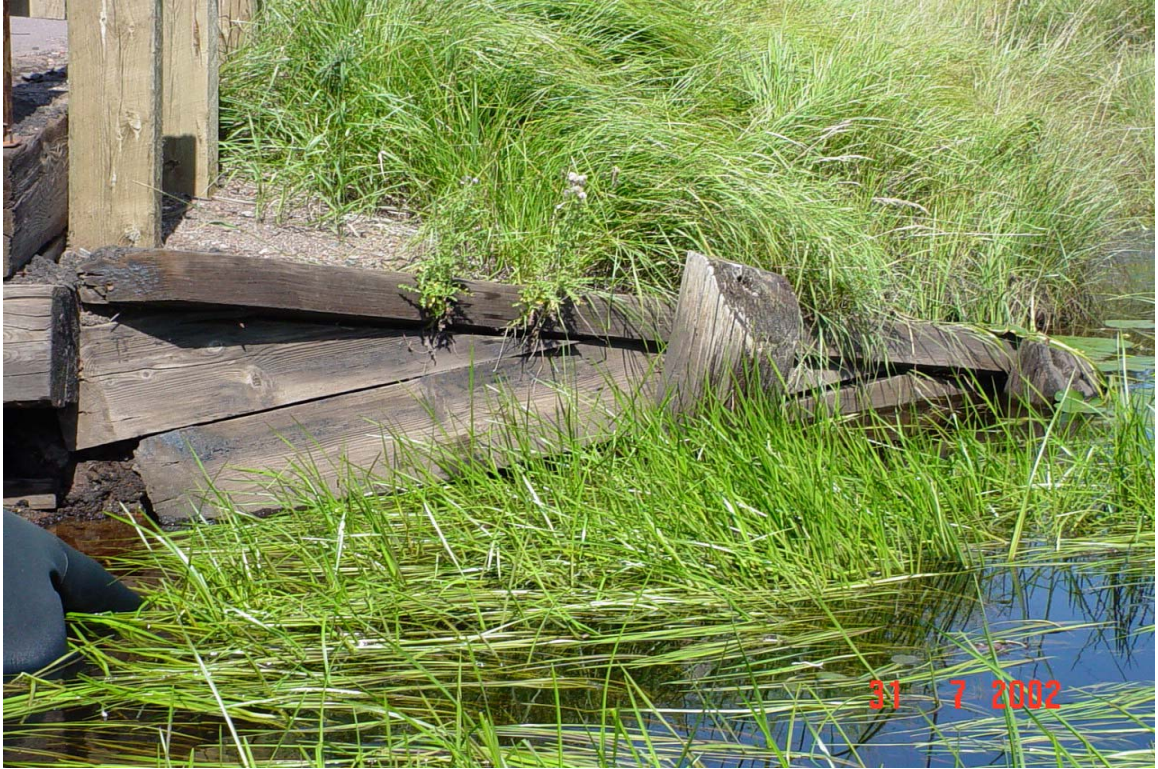
- (C) The pile cap at the North Abutment was rotated towards the embankment and was held in place with steel beams and shims. The northeast wingwall has failed and the east end of the backwall exhibited considerable movement with backfill escaping through 1-inch gaps between the planking. A portion of the backwall along the west end also exhibited a 1-foot-wide by 6-inch-high gap with 6 inches of penetration and signs of backfill escaping.

Photograph 5. View of the Northeast Wingwall, Looking North.

- (A) Ideally, the North Abutment backwall and its northeast wingwall should be rebuilt and/or repaired to prevent further loss of backfill under the approach. Until repairs can be made, above and below water inspection should monitor the failing North Abutment components.
- (B) Reinspect the submerged substructure units at the normal maximum recommended (NBIS) interval of five (5) years.

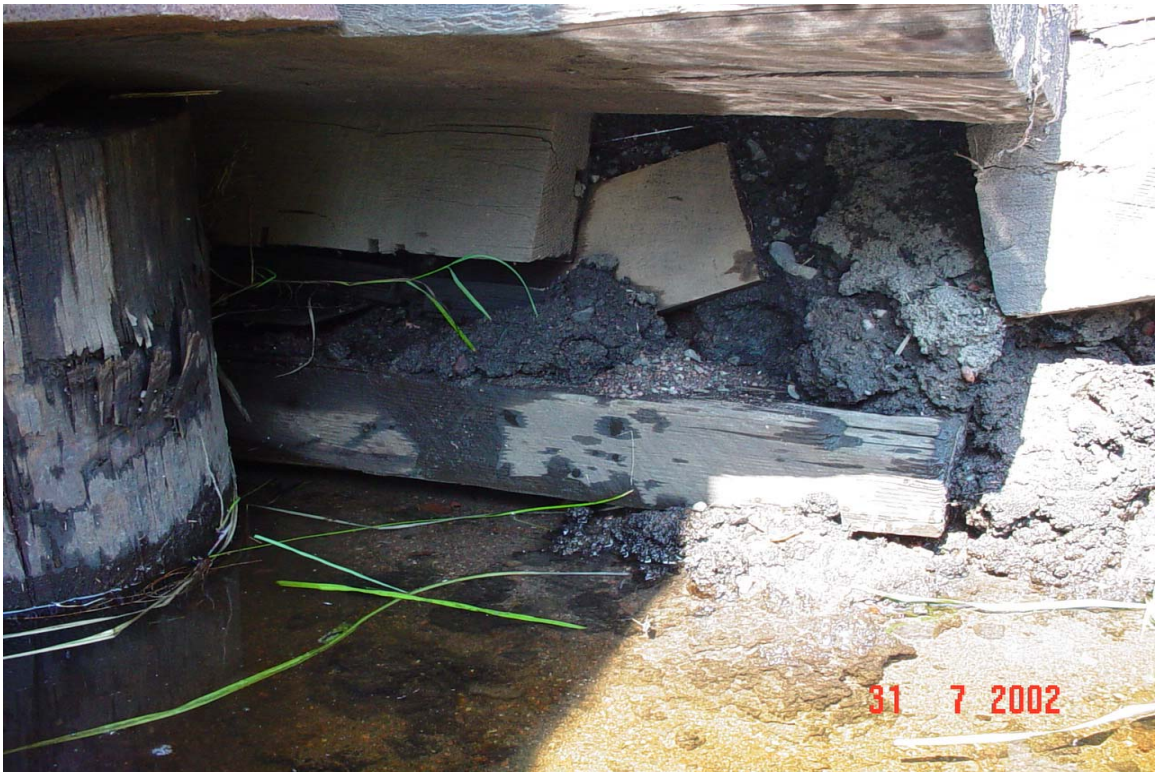
Photograph 6. View of the Failing Backwall at North Abutment, Looking North.

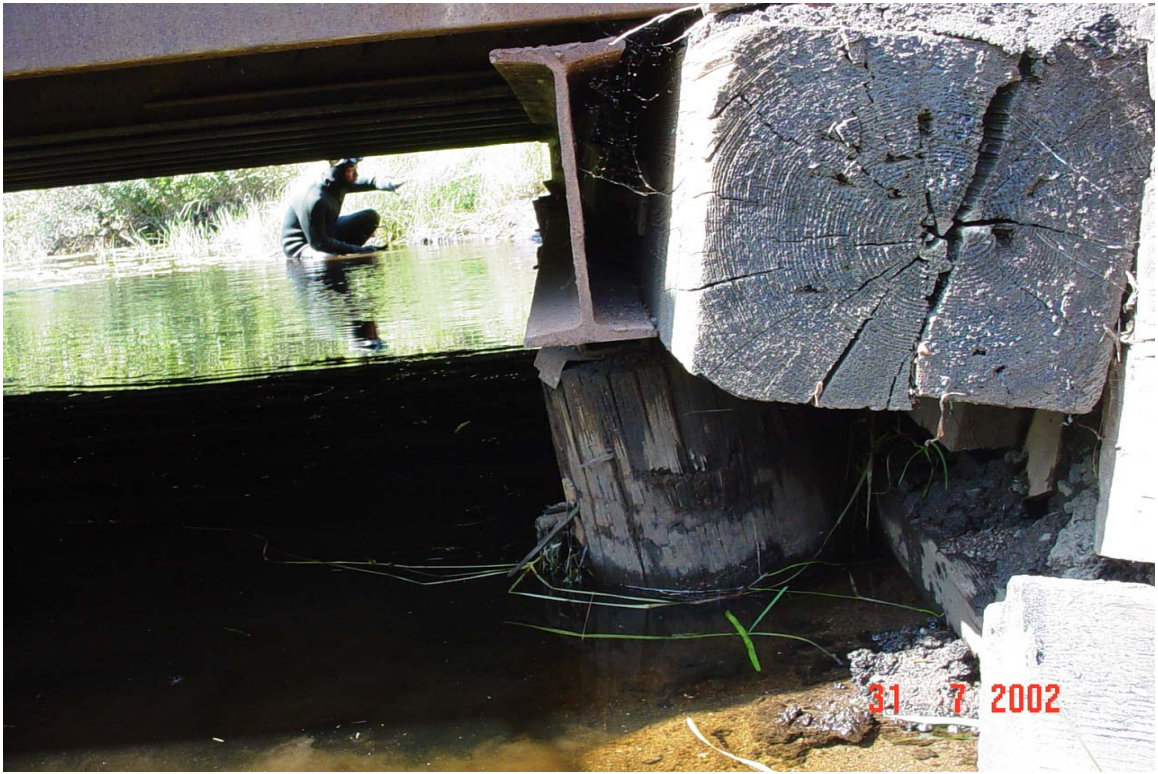
Photograph 7. View of the North Abutment, Looking West.

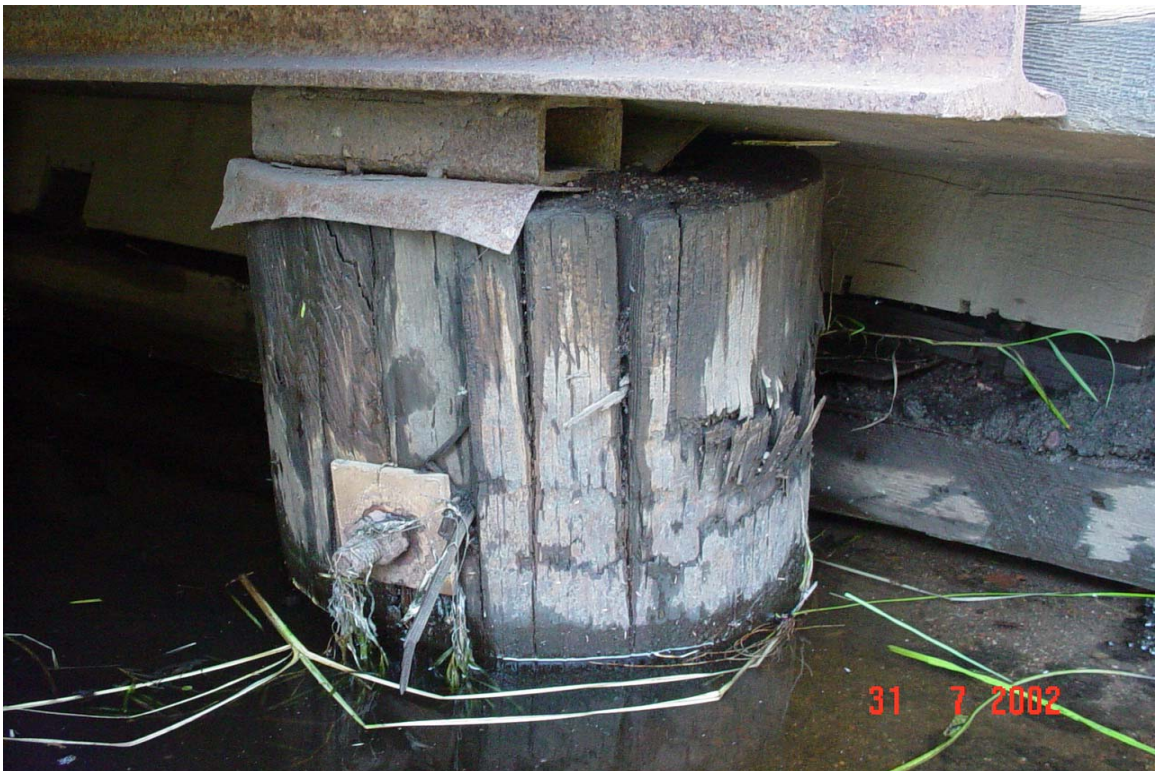
- (B) Three timber piles at the North Abutment exhibited splitting and delamination around the entire circumference with the outer 1-inch thick shell being most affected.

Photograph 8. View of Pile 1 at North Abutment, Looking Northwest.
